## ANALYZING THE IMPACT OF LANDUSE ON EROSION RATES ON THE CAPACITY OF SABO DAMS

Landuse changes in the Bangga Watershed, Sigi Regency, Central Sulawesi, have become the main factor increasing erosion and sedimentation threatening the capacity of Sabo Dam. This study aims to analyze the effect of landuse change on erosion and sedimentation rates and evaluate the Sabo Dam's capacity to reduce sediment. The method used is a quantitative approach using the Universal Soil Loss Equation (USLE) model to calculate erosion rates and the USDA Sediment Delivery Ratio (SDR) method to estimate sediment transport. Analyzes were conducted on landuse data for the 2013–2025 period, rainfall, soil types, and slope gradients using Geographic Information Systems (GIS). The results show that the conversion of 912.99 Ha of secondary forest into shifting cultivation areas exponentially increases erosion, especially on steep slopes (>45%) with erosion values reaching 4,224 Ton/Ha/Year. The highest erosion occurred in 2019 after the flash flood, reaching 106,532.60 Ton/Ha/Year. The Sabo Dam with a capacity of 8,500,000 m<sup>3</sup> is still able to accommodate the highest total sediment (8,176,943.79 m<

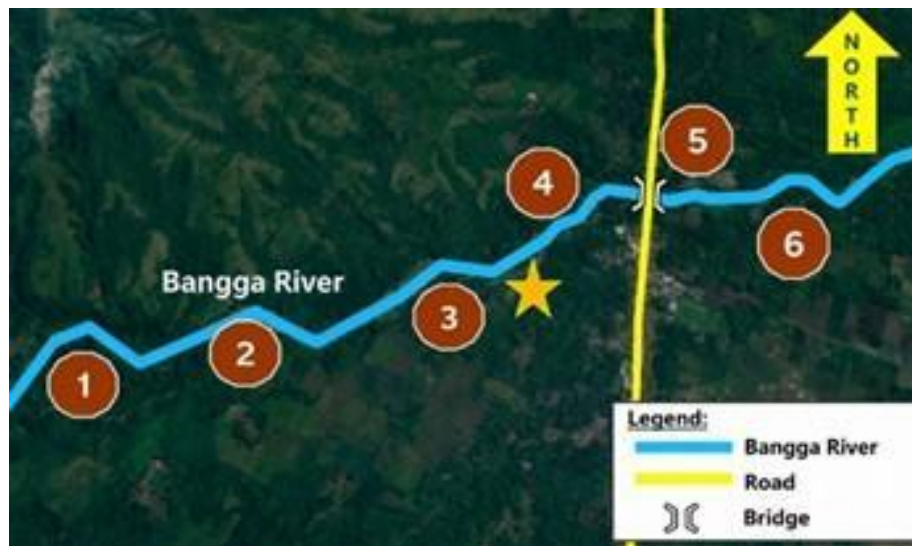
Figure 1. Location of Sediment Control Structures  
(Source: BWS III Palu)

Administratively, the Bangga Watershed is located in the administrative area of Dolo Selatan District, Sigi Regency, Central Sulawesi Province. The Bangga Watershed is part of the Palu River sub-basin. Based on the initial survey conducted, there are several sediment control structures already in the Bangga River, namely 3 Sabo Dams, 1 Dam Bridge, 2 Consolidation Dams with a storage capacity of 3,100,000 m<sup>3</sup>.

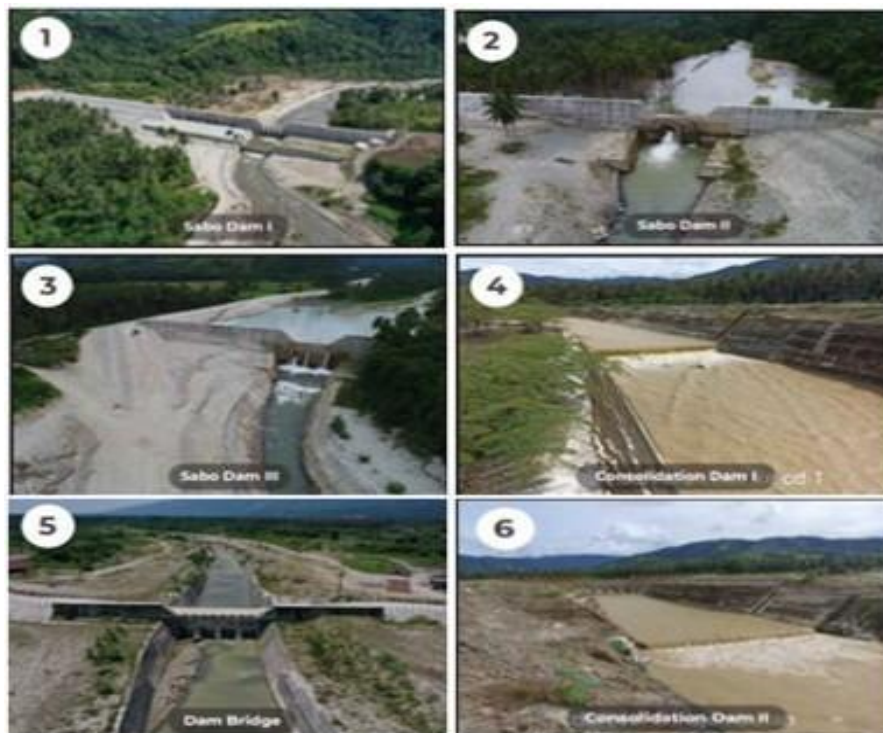
Figure 2. Image of Sediment Control Structures in the Bangga River
